Intel[®] Pentium[®] III Xeon[™] Processor Specification Update

Release Date: August 2000

Order Number: 244460-018

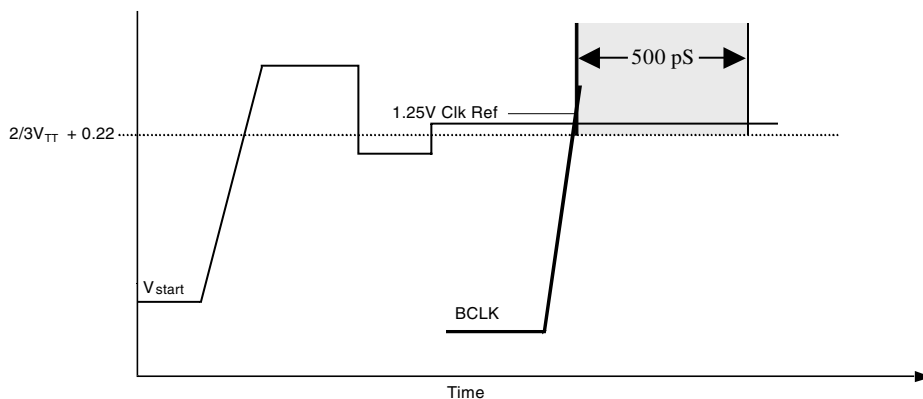
The published AGTL+ AC specification for $V_{IH(MIN)}$ is $(2/3 \cdot V_{TT}) + 0.1$ Volts.

Intel has characterized the new AGTL+ AC specification for $V_{IH(MIN)}$ on the processor's RS0# signal to be: $(2/3 \cdot V_{TT}) + 0.22$ Volts within 500 picoseconds following the rising edge of BCLK crossing the 1.25-Volt threshold. See below.

Implication: The deviation from the published specification results in decreased noise margin on the RS0# processor input. This decreased noise margin has been observed to be particularly detrimental in system environments where the RS0# processor input is being driven by an I/O buffer with a pull-up device (such as a p-channel transistor) that is switched off mid-cycle. Systems that employ I/O buffers that keep the pull-up device on for the entire cycle are significantly less affected by this erratum. The reduction in noise margin may lead to the generation of BINIT# (when enabled) resulting in a system reset, otherwise this condition may lead to a system "hang" condition.

Workaround: If a system design cannot meet the specification deviation, the following areas should be carefully examined to assure that additional margin exists in order to compensate for any deficit observed with respect to the newly characterized $V_{IH(MIN)}$ specification:

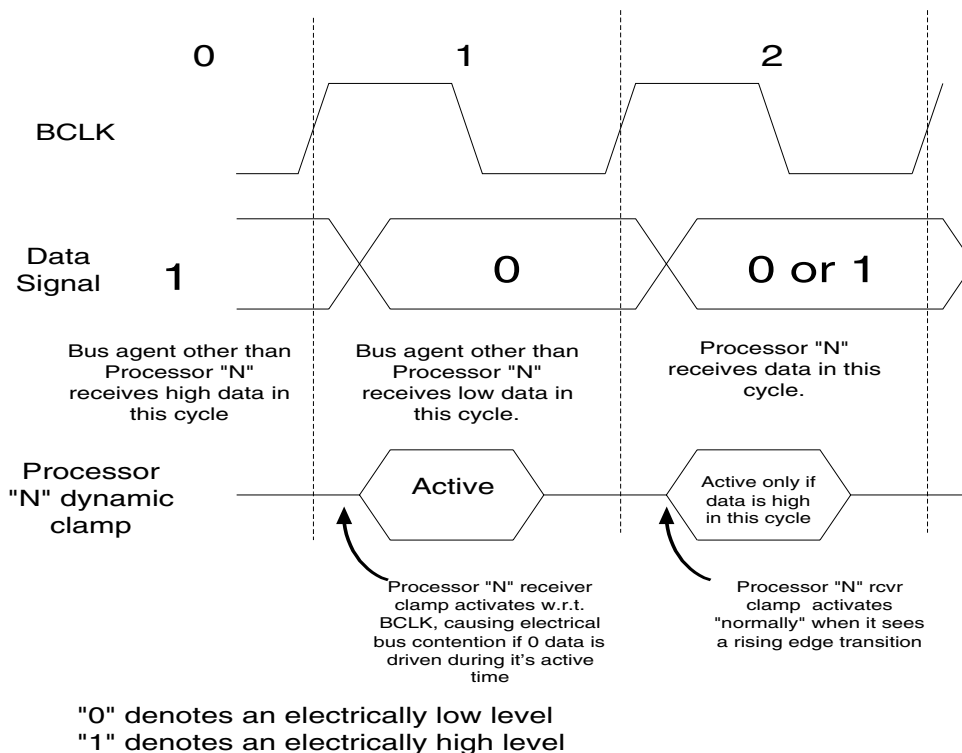
Problem: Falling edge ledge push-out and undershoot may be seen on AGTL+ data and data bus ECC signals. The AGTL+ receiver's dynamic clamp circuit activates (i.e. clamps the signal to an electrically high level) in certain cycles when data is driven to an electrically low level by another agent.

Implication: This erratum only occurs on a processor that does not receive data in that particular cycle. More specifically, this erratum only occurs when a specific processor does not receive data in the current BCLK period, but receives data in the very next period. Therefore, the processor inducing this falling edge noise (on data and data bus ECC signals) will not actually read the data in that cycle. See below for an illustration of this erratum affecting a processor denoted Processor "N". The falling edge ledges and undershoots may affect the signal quality and/or timing at agents that receive data in that cycle. Therefore, the impact of this erratum is highly dependent on system bus design.

Workaround: Evaluate system bus signal quality and timing margin at the valid receiving agent as a result of this falling edge noise. Due to dependence upon system bus design, bus layout may be evaluated to determine the need for improvements in signal quality and timing margin at the valid receiving agent as a result of this receiver-induced falling edge noise.
